**Archeological and Architectural Investigations
at Brown's Sheep Camp (5LA5824),
A Multicomponent District in the
U.S. Army Pinon Canyon Maneuver Site,
Las Animas County, Colorado**

**National Park Service,
Midwest Archeological Center,
Lincoln, Nebraska**

April 1999

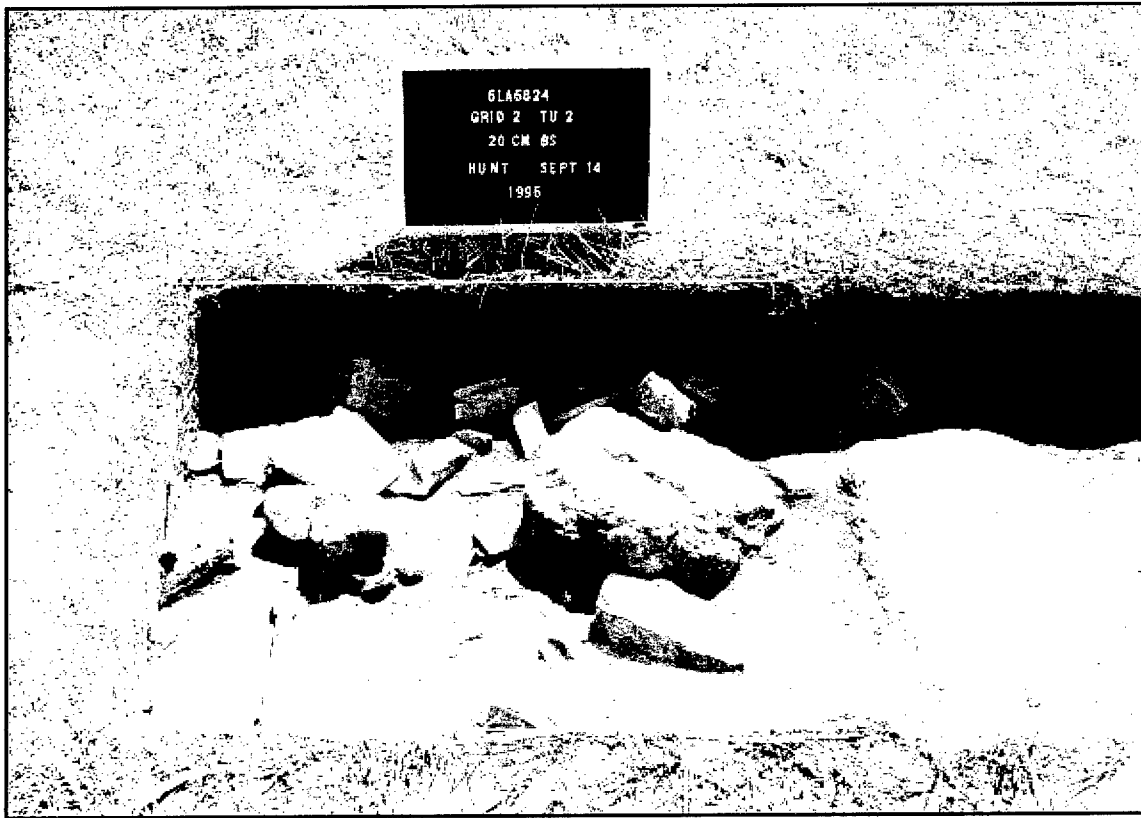
Figure 6. Artifacts and cultural features exposed in Remote-Sensing Grid 2 test units.

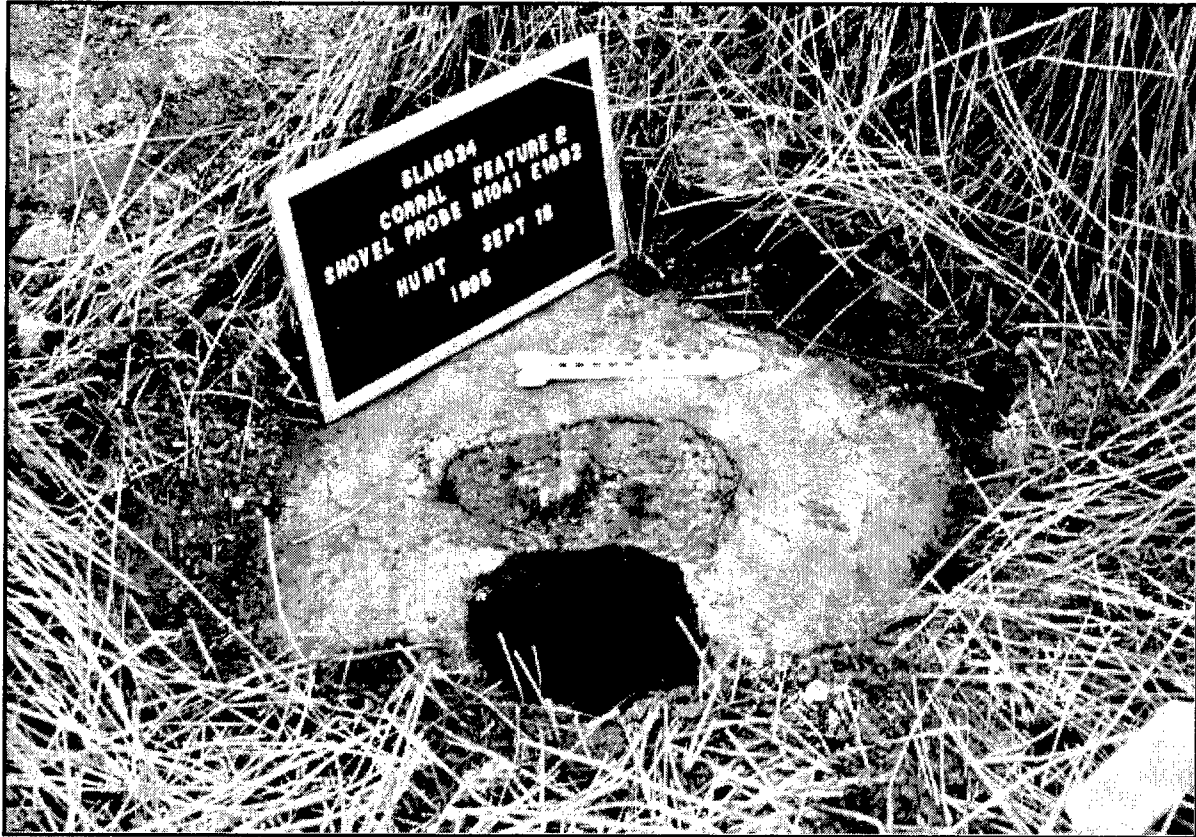
Figure 9. Post mold (Feature 2) located with shovel probe at N1041/E1092, Remote-Sensing Grid 3 (Corral) test area.

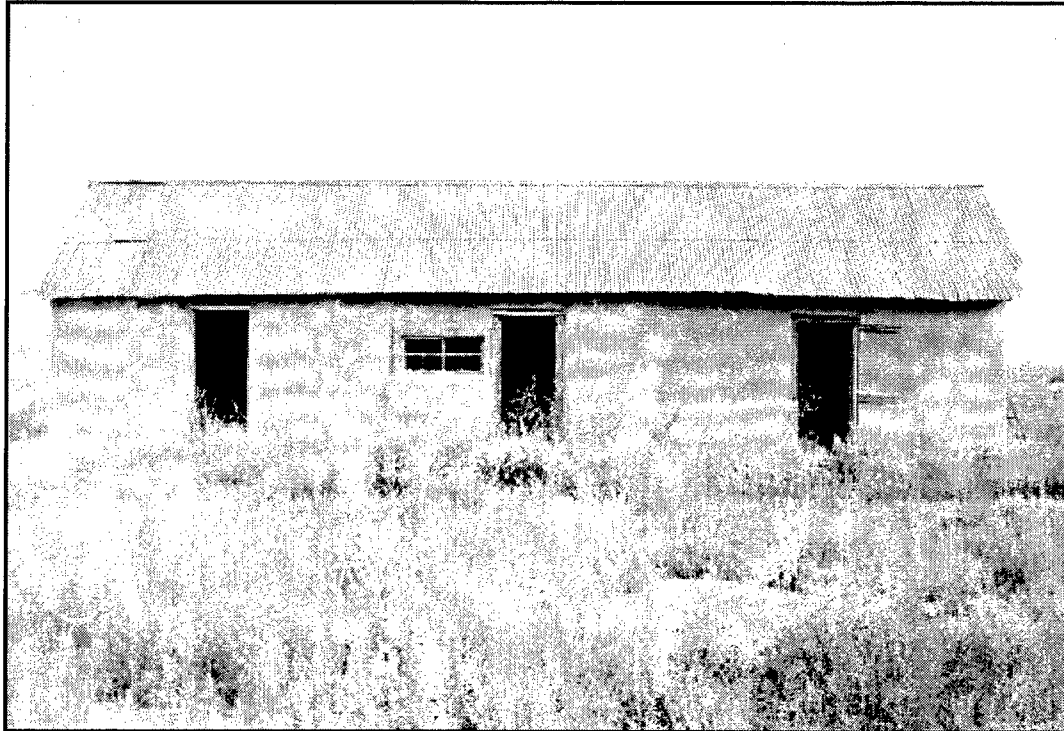
Figure 11. Structure A (Original Residence) south face (top) and east face (bottom) showing alto and gate at left.

The *alto* is a Hispanic design element which allows access to an uninsulated storage space created by the addition of the gable roof. The *alto* is accessible only by an exterior door constructed of two wood planks (Figure 11, bottom). This entrance has a full surround of 1"-x-4" boards, though the bottom member is now missing. The *alto* door is fastened with a slide bolt.
